# **ICC WITH HIPRO-H12 SCANNER**

**Input Hopper Tray Error Message  
(ICC Software v. 5.10, Scanner Firmware 1.0.1019)  
Certification Testing**

## **ROOT CAUSE ANALYSIS**

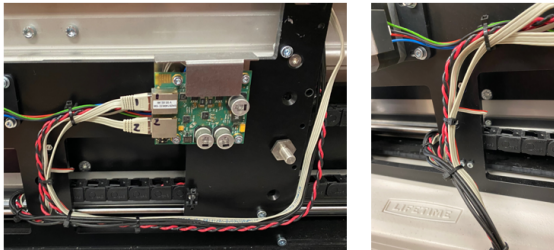
Harness Cable-Stepper Control PCB to Motion Control PCB

It was determined that the error message is caused by one of the interconnection cables between motor control board and main control unit. Further investigation of cable revealed an intermittent connection in the RJ45 connector of the cable.

InterScan's and Dominion technician confirmed that the harness cable which connects the Stepper Control PCB to the Motion Control PCB had an intermittent connection inside the connector.

After replacing the harness cable on the HiPro-H12, the error message could not be replicated. 5000 scans were conducted using 11" and 14" ballots.

To overcome the issue of the Input Hopper Tray's error message, the damaged harness cable was replaced with a new one to correct the communication between the Motion Control PCB and the Stepper Control PCB.
