**DOMINION VOTING SYSTEMS
InterScan 821D HiPro Scanner
Modification to DemSuite 5.2
Administrative Approval Report**

**Components:
InterScan 821D HiPro Scanner,
Dell OptiPlex 7040 Workstation,
ImageCast Central Version 5.2.2.7**

**Staff Administrative Approval Report
Prepared by:
Secretary of State's Office of
Voting Systems Technology Assessment
May 8, 2018**

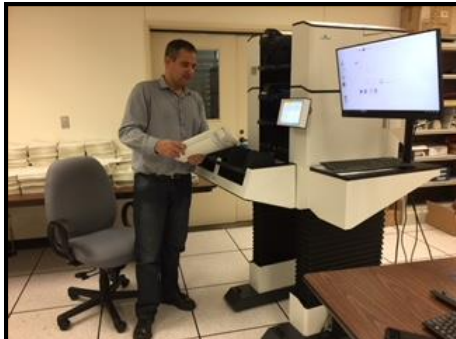
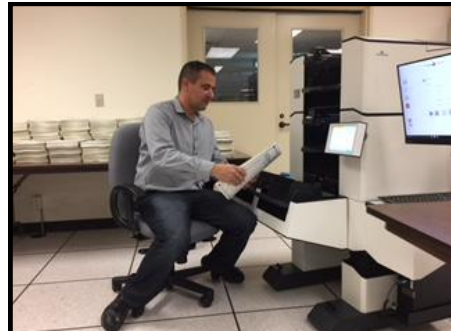
The Interscan 821D HiPro scanner, while not a voter usable device, includes the ability to lower and raise in order to accommodate an elections office worker.

It was found that the Interscan 821D HiPro scanner is easily adaptable for sitting or standing elections workers. It was determined that the technologies implemented for accessibility and usability in the Interscan 821D HiPro scanner improved the experience for election workers that may be required to spend hours at a time operating the Interscan 821D HiPro scanner.
